WEATHERBY DAM
PLATTE COUNTY, MISSOURI
MO. 10690

PHASE 1 INSPECTION REPORT NATIONAL DAM SAFETY PROGRAM

SUBJECT: Weatherby Dam Phase I Inspection Report

Name of Dam	Weatherby Dam
State Located	Missouri
County Located	Platte County
Stream	Rush Creek
Date of Inspection	5 September 1978

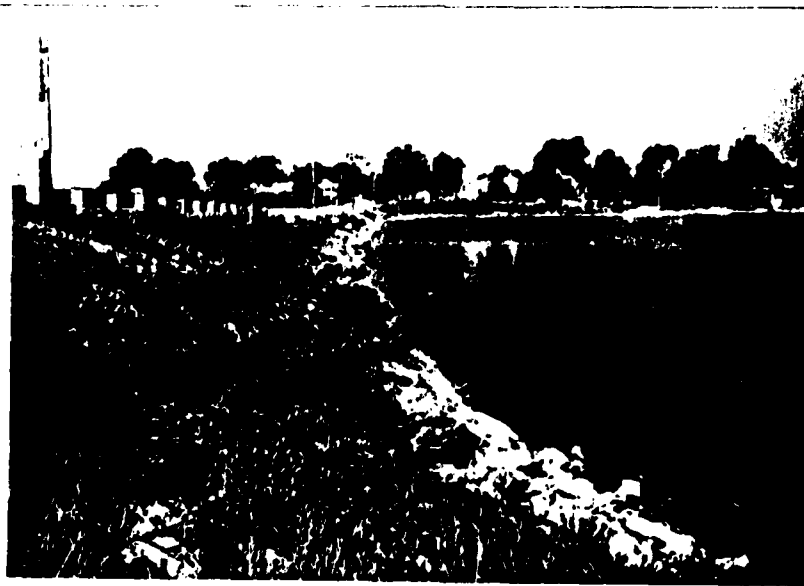
(1) The movement of riprap on the upstream face exposes the embankment material to wave action.

PHOTO 1: Upstream Face of Dam (Looking West)

(4) Additional erosion protection should be added on the upstream slope in the areas of riprap movement. This protection is needed to prevent erosion of the embankment material due to wave action.

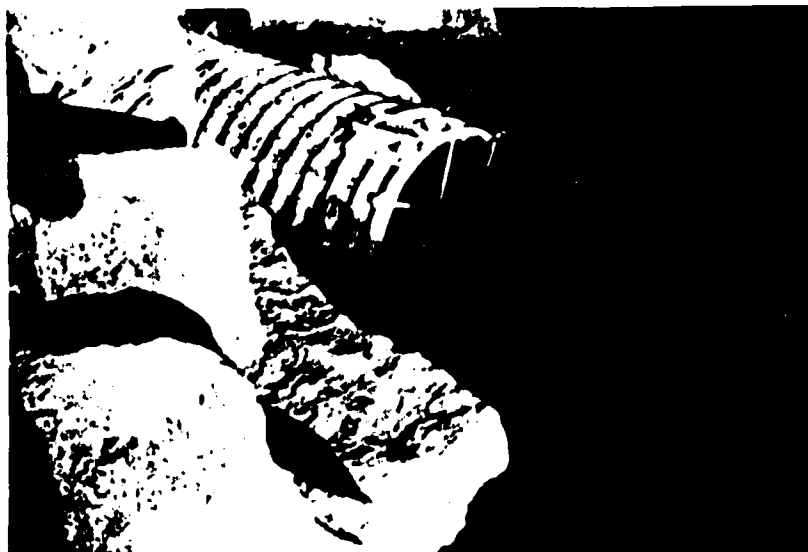
The 24-inch diameter lake drawdown pipe and gate well appeared to be in good condition at the time of inspection. The pipe runs through the upper portion of the embankment where it spills onto the concrete discharge apron. The operator handle was missing; thus, the gate could not be checked for operation. No water was discharging through the outlet culvert at the time of inspection.

PHOTO 3: Inlet of 24-inch Diameter Outlet Pipe
